CHAPTER 4

EVALUATION OF EXPERIMENTAL TEST RESULTS

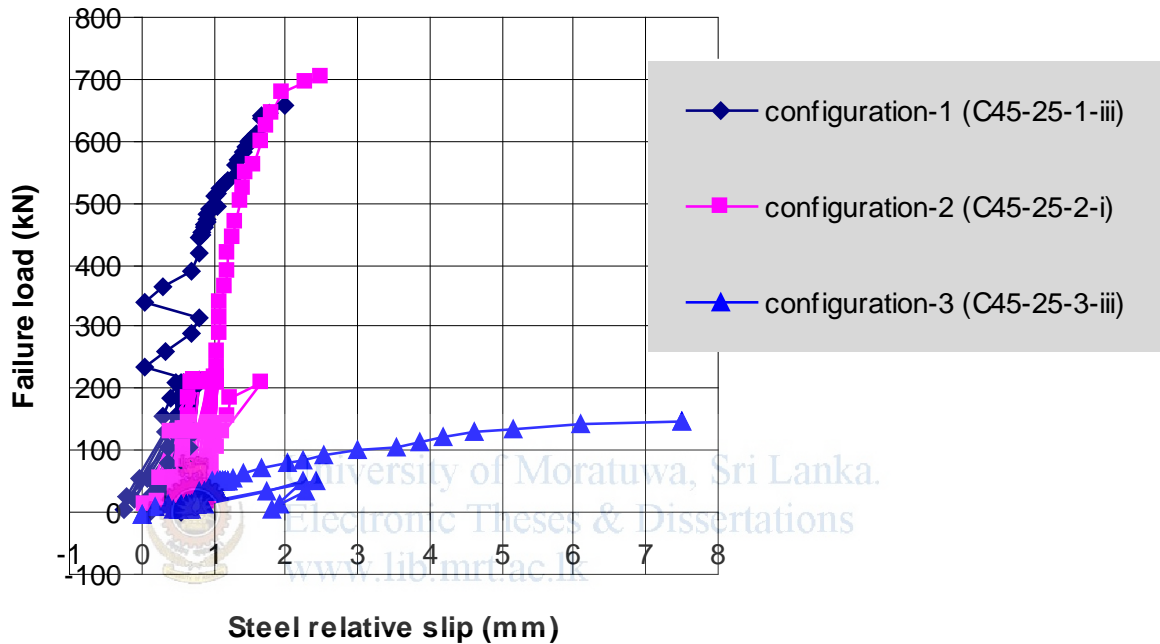
Figure 4.1: Experimental Connection Behaviour

For configuration 3 that is shear connection with headed shear studs the plots against slip, and failure load were showed Figure 2.2 (a) type behaviour. But both configurations 1 and 2 were showed Figure 2.2 (b) type behaviour. As a result of those, it can state that configuration 3 shear connection is ductile and both configurations 1 and 2 have non-ductile shear connection (see Figure 2.2, 4.1).

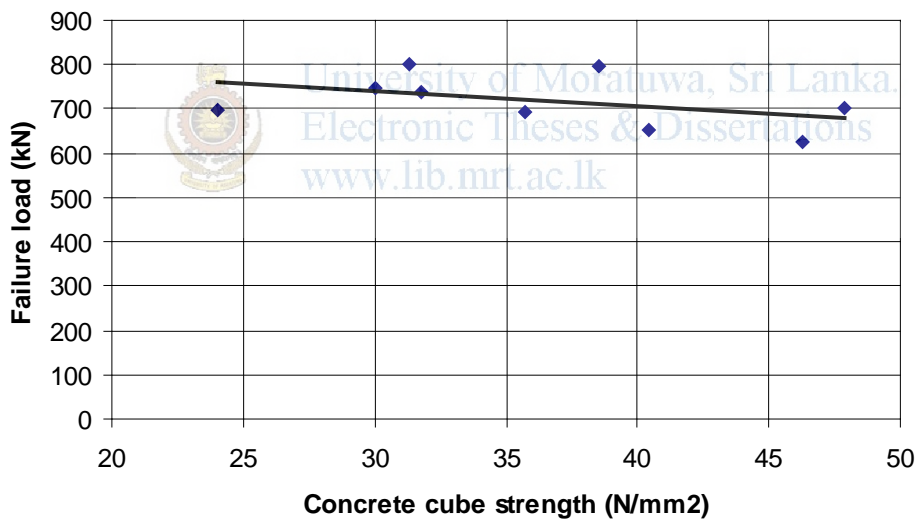
Figure 4.3: Effect of Concrete Strength on Failure Load on Configuration-2 (for concrete top cover 25mm)

With configuration 1 and 3 the failure load increased with increase of concrete strength (16%- 21%, 20%- 53% respectively). It appears that there is no influence of concrete

strength in configuration 2. That might be due to effective mechanical bond between concrete and shear connector (see Figure 4.2, 4.3, 4.4, 4.5).

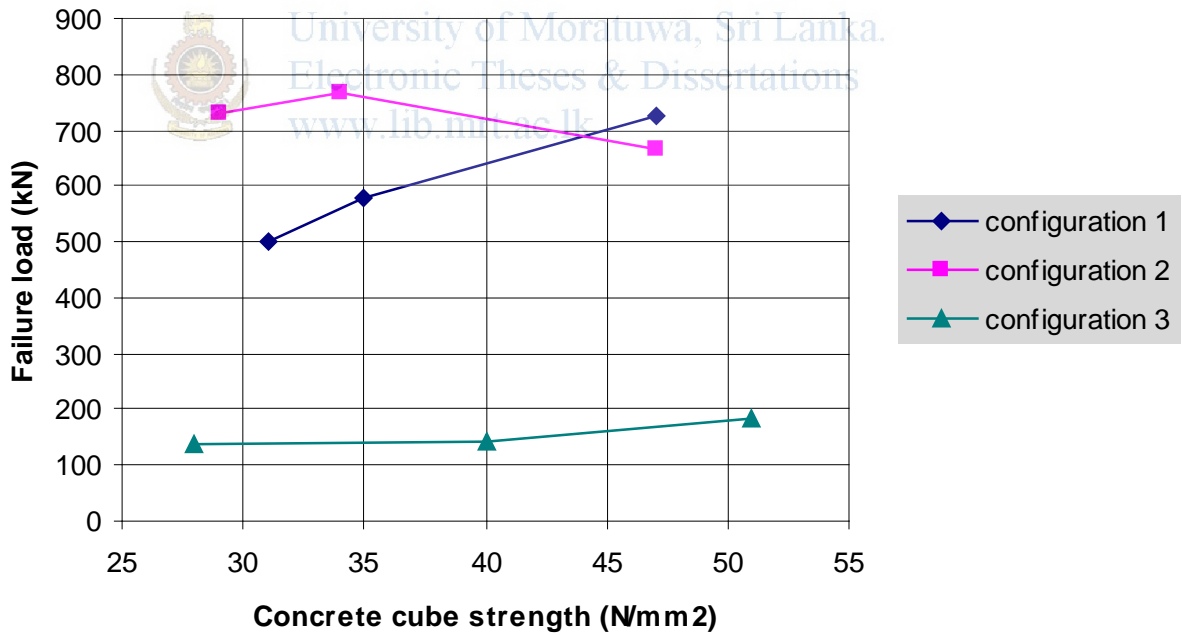
Figure 4.5: Effect of Concrete Strength on Failure Load on Different Configurations (for concrete top cover 25mm)

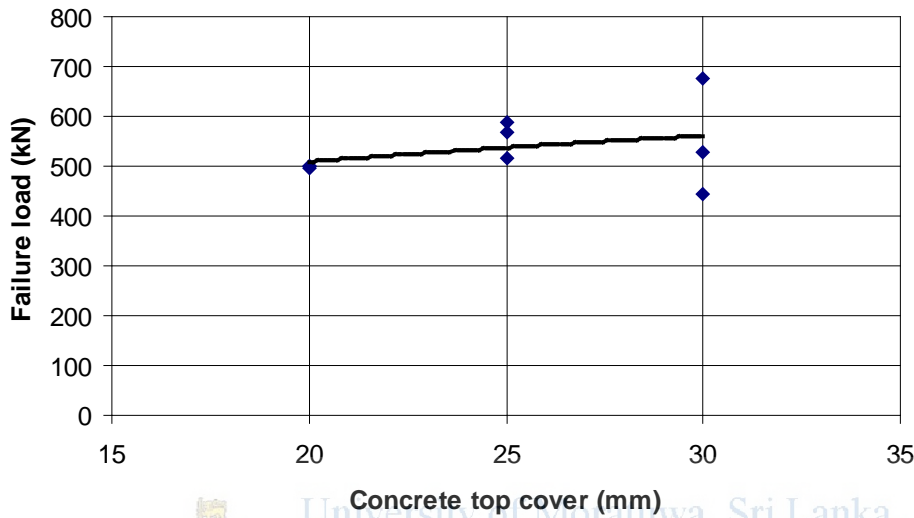
Figure 4.6: Effect of Concrete Top Cover on Failure Load on Configuration-1 (for grade 30 concrete)

With configuration 1 and 3 the failure load increased with increase of concrete top cover (16%- 45%, 23%- 29% respectively). It appears that there is no influence of concrete top

cover in configuration 2. That might be due to effective mechanical bond between concrete and shear connector (see Figure 4.6, 4.7, 4.8, 4.9).

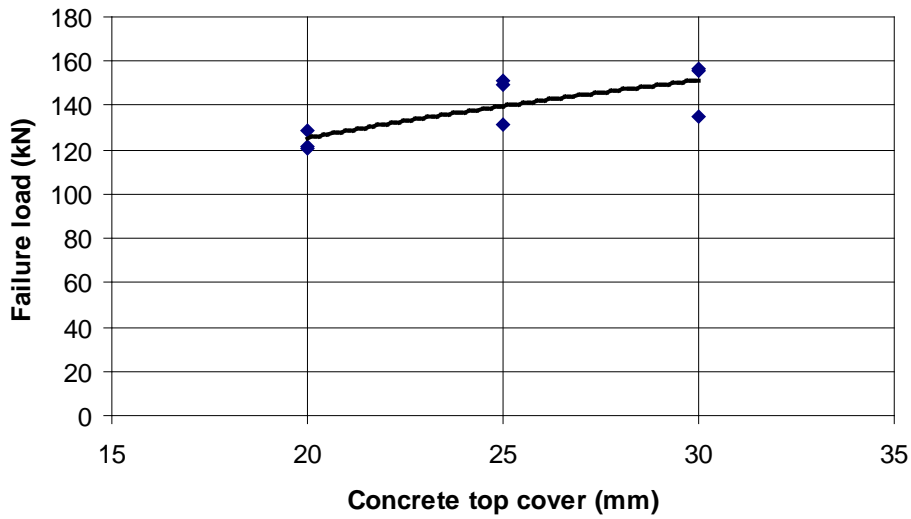
Figure 4.8: Effect of Concrete Top Cover on Failure Load on Configuration-3 (for grade 30 concrete)

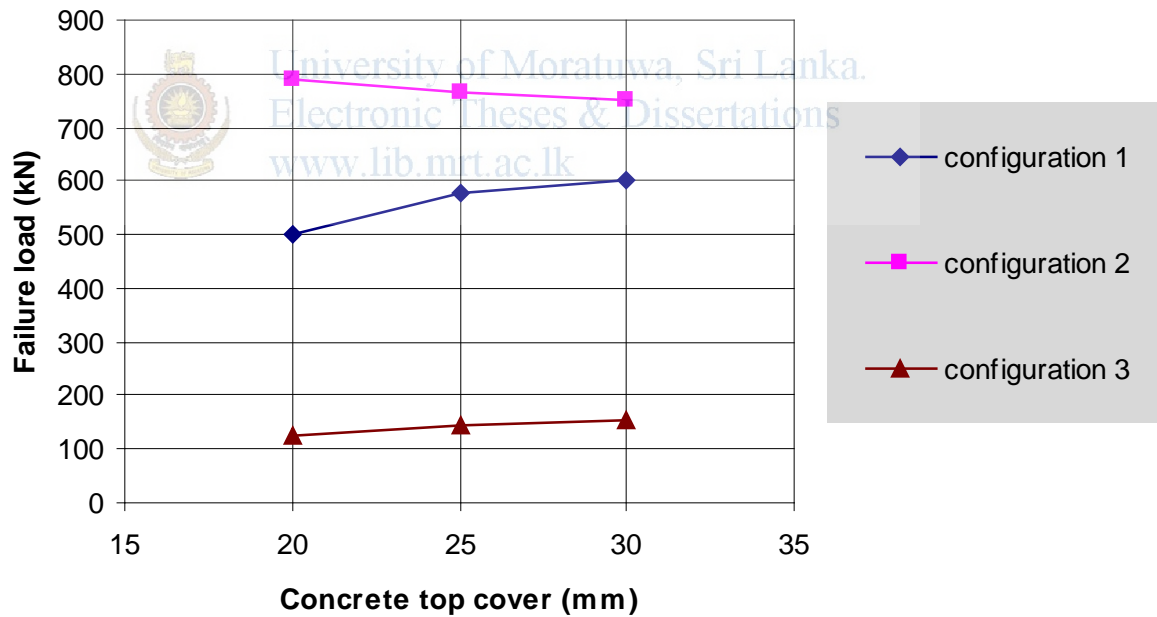
Figure 4.9: Effect of Concrete Top Cover on Failure Load on Different Configurations

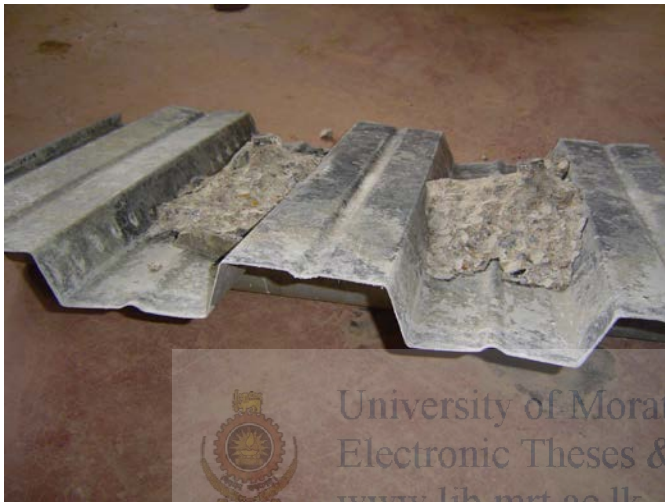
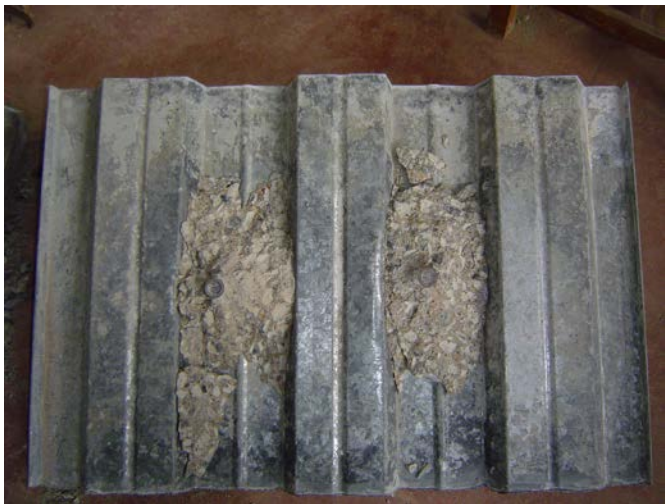
(a) Elevation

(b) Plan

Figure 4.10: Wedge Cone Failure Surface (a) Elevation (b) Plan

In both configurations 1 and 2, longitudinal shear failure cracks were propagated due to loss of shear connection at the concrete steel interface. But in configuration 3 wedge cone failure surface were found (see Figure 4.10). According to the past research work (Hawkins and Mitchell (1984)), increase of shear failure surface area considerably increases that shear carrying capacity of composite slabs (Equation 2.8).

For configuration 1, failure surface area was taken as steel tube surface area. But it was added to two steel strip areas for configuration 2 failure surface area. For configuration 3, failure surface area was taken as wedge cone area (Hawkins and Mitchell (1984)).

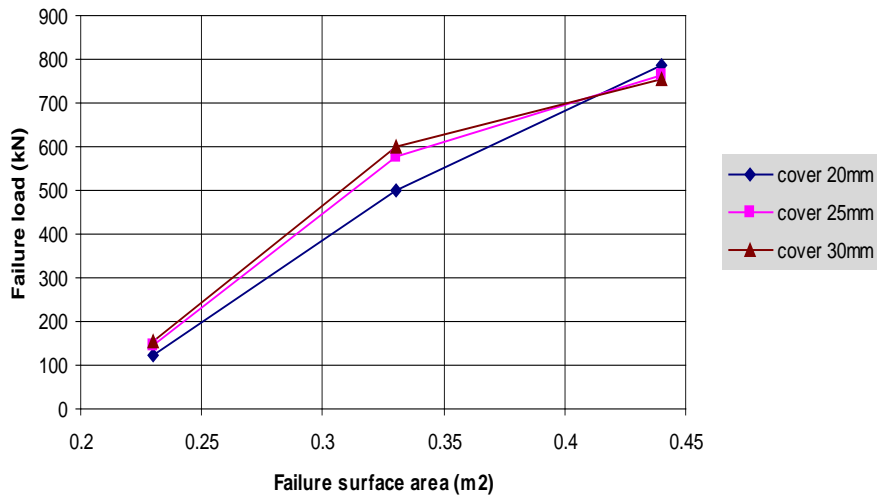
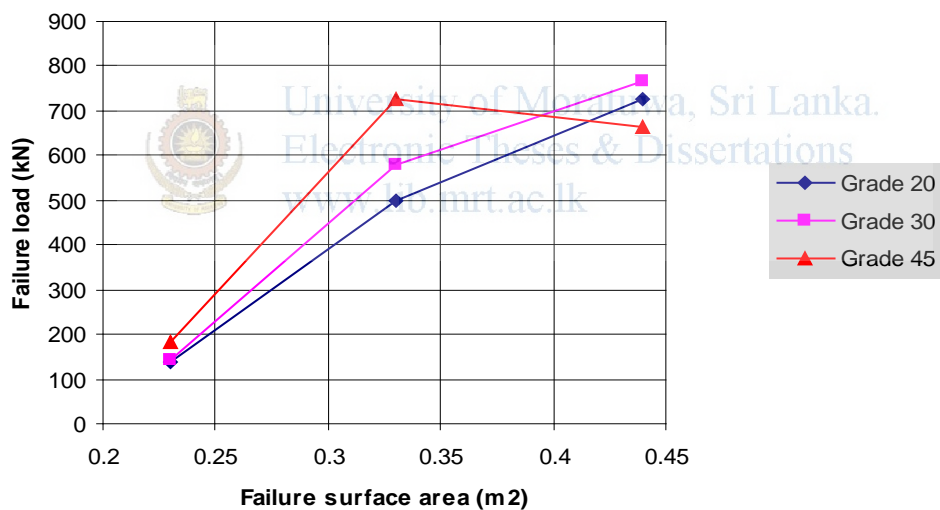
(a) For Concrete Grade 30

(b) For Concrete Cover 25mm

Figure 4.11: Effect of Concrete Failure Surface Area on Failure Load on Different Configurations (a) Concrete Grade 30 (b) Concrete Cover 25mm

For both configurations 1 and 2 the failure surface areas are higher than configuration 3. Irrespective of concrete strength and concrete top cover, the configurations 1 and 2 gave higher failure load than with headed shear studs in configuration 3. Between configurations 1, and 2, configuration 2 gave higher shear carrying capacity, as its concrete failure surface area is higher than configuration 1 (see Tables 4.4 and 4.5, Figure 4.11).

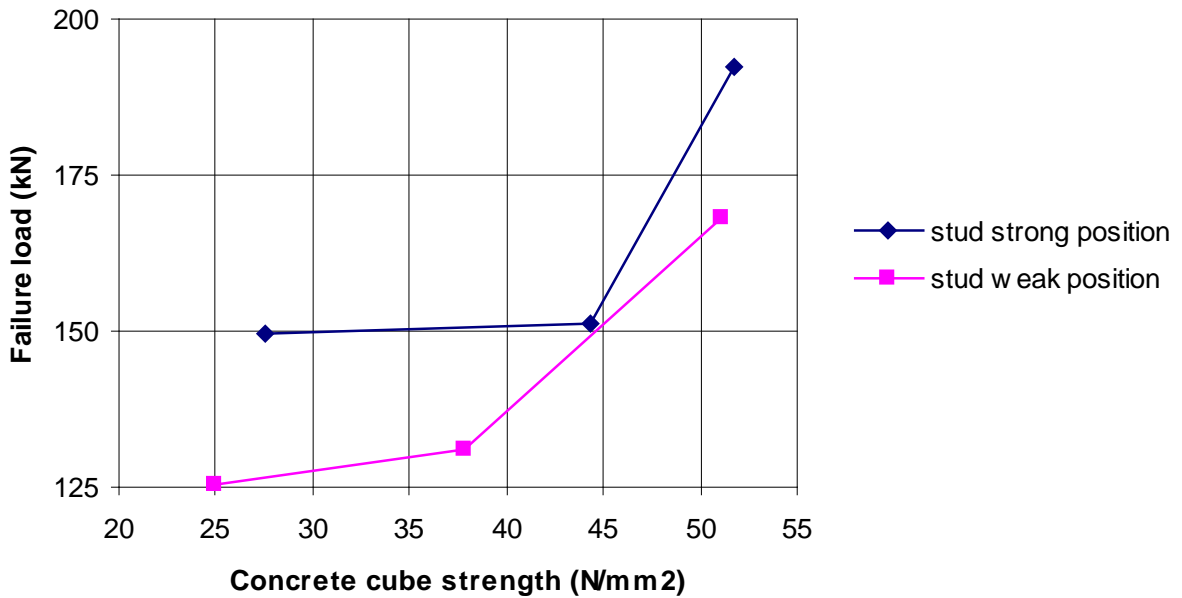
Figure 4.12: Effects of Stud Position and Steel Tube on Shear Capacity (a) For Concrete Top Cover 25mm (b) For Concrete Top Cover 25mm and Stud Weak Position

The effect of position of shear stud was described with concrete top cover 25mm since it has more test results. The effect of position of shear stud was not considerable with reference to Table 4.6 and Figure 4.12(a). But shear carrying capacity of stud strong position was slightly higher than stud weak position. According to past research (Mottram and Johnson 1990); it was also found that the effect of position of shear stud in steel deck is not considerable when it is shallow deck, in this study that used steel decks were shallow (Figure 3.1).

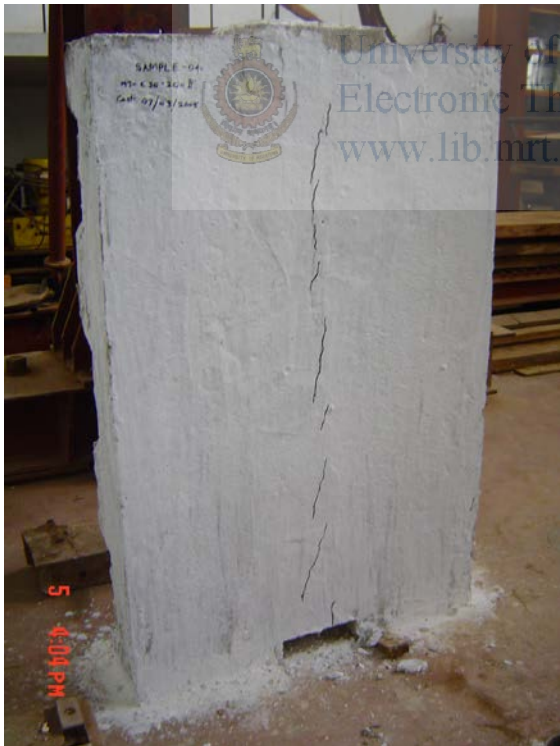
The shear failure pattern of configuration 1 is shown in Figure 4.13; the longitudinal crack was propagated on top of the embedded steel tube. The failure of the composite slab is mainly due to loss of friction force at steel concrete interface and it is shown in Figure 4.14 (first crack at nearly 83% of failure load).

Figure 4.13: Configuration 1 Shear Failure Pattern

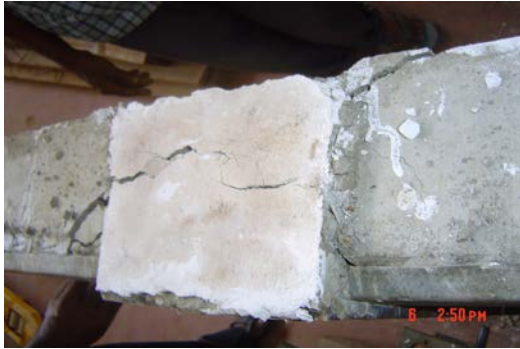
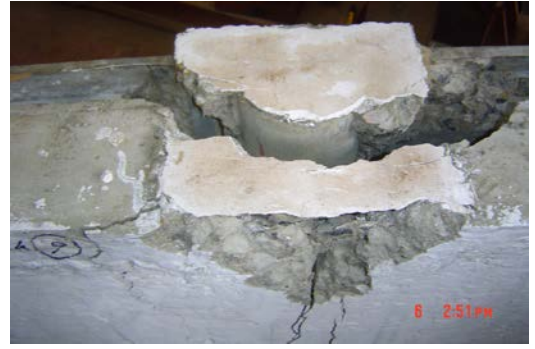
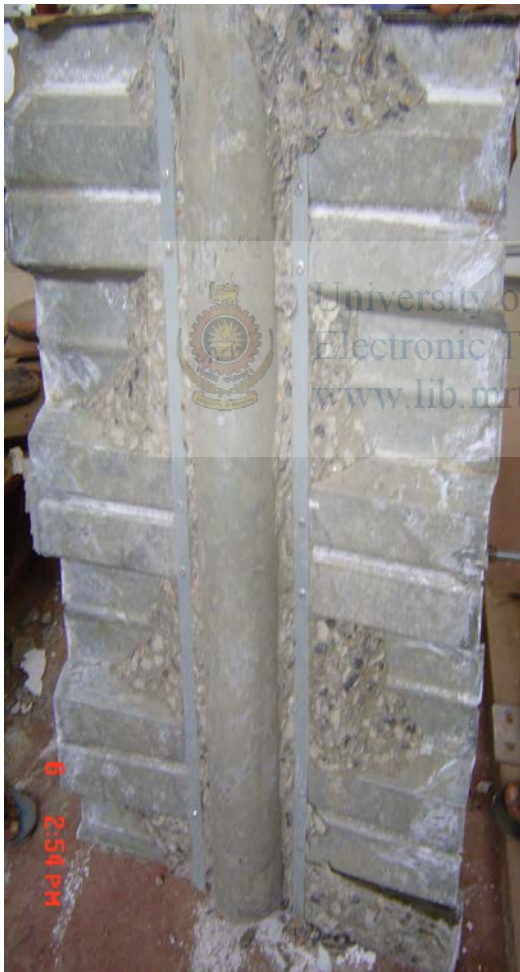
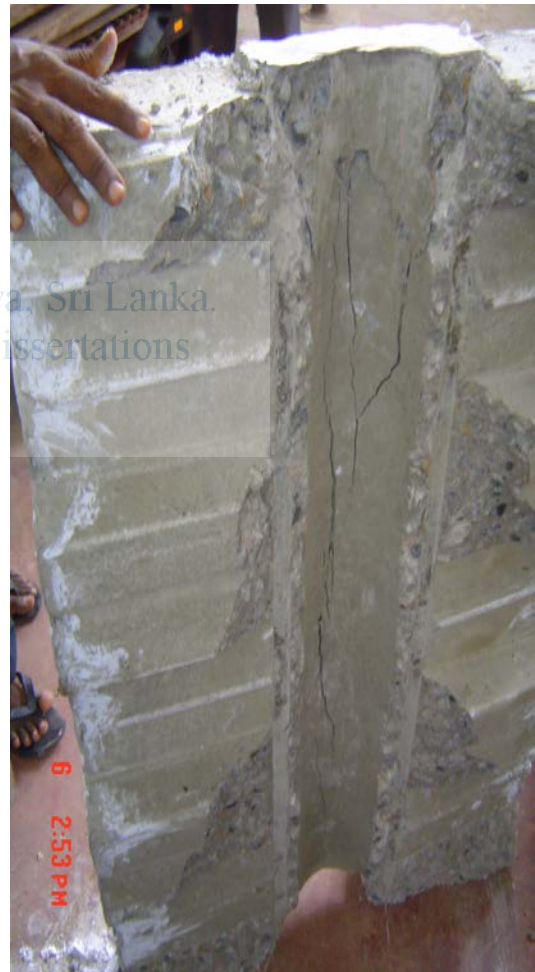
Figure 4.14: Configuration 1 Failure Surface

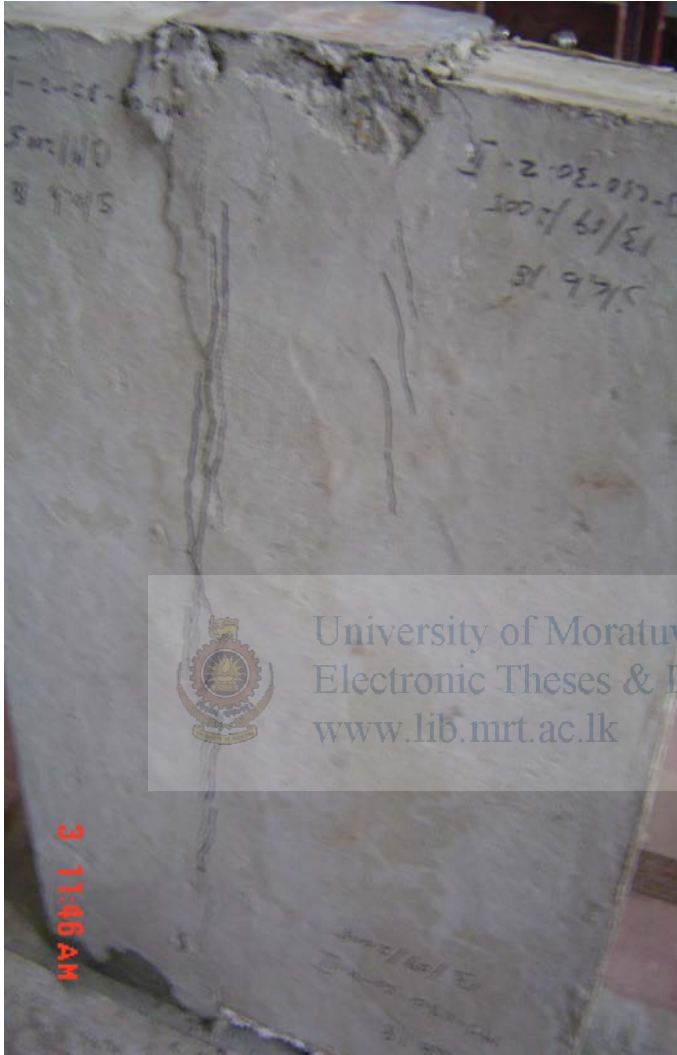
The shear failure pattern of configuration 2 is shown in Figure 4.15; two longitudinal cracks were propagated on top of the steel strips, which were welded to the embedded

Figure 4.15: Configuration 2 Shear Failure Pattern

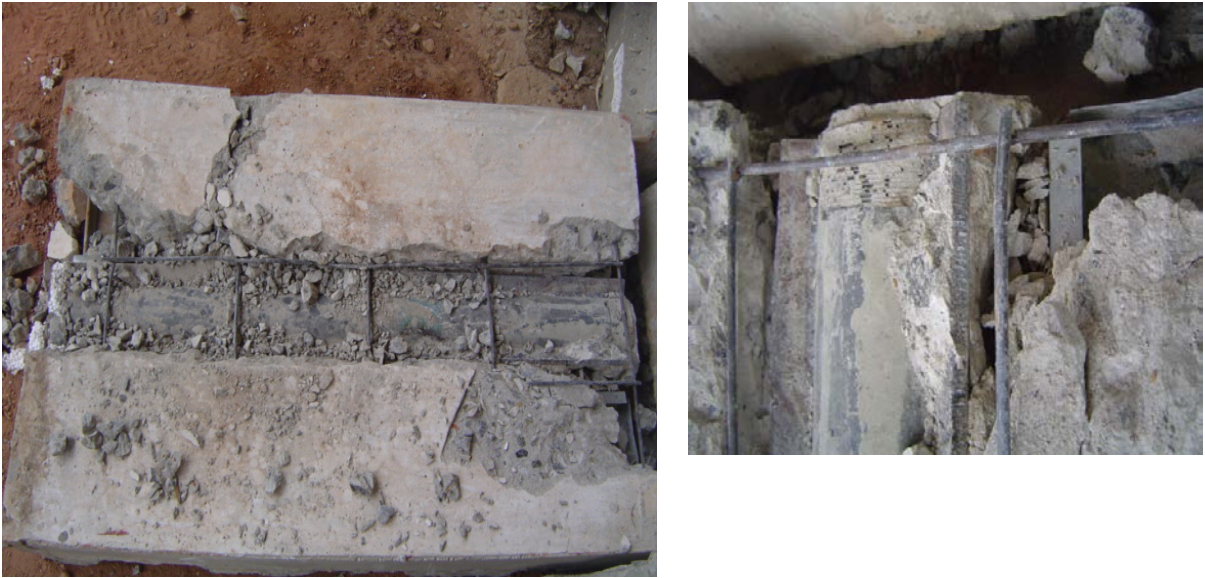
steel tube. The failure of the composite slab is mainly due to loss of friction force at steel concrete interface and it is shown in Figure 4.16 (first crack at nearly 83% of failure load).

Figure 4.16: Configuration 2 Failure Surface

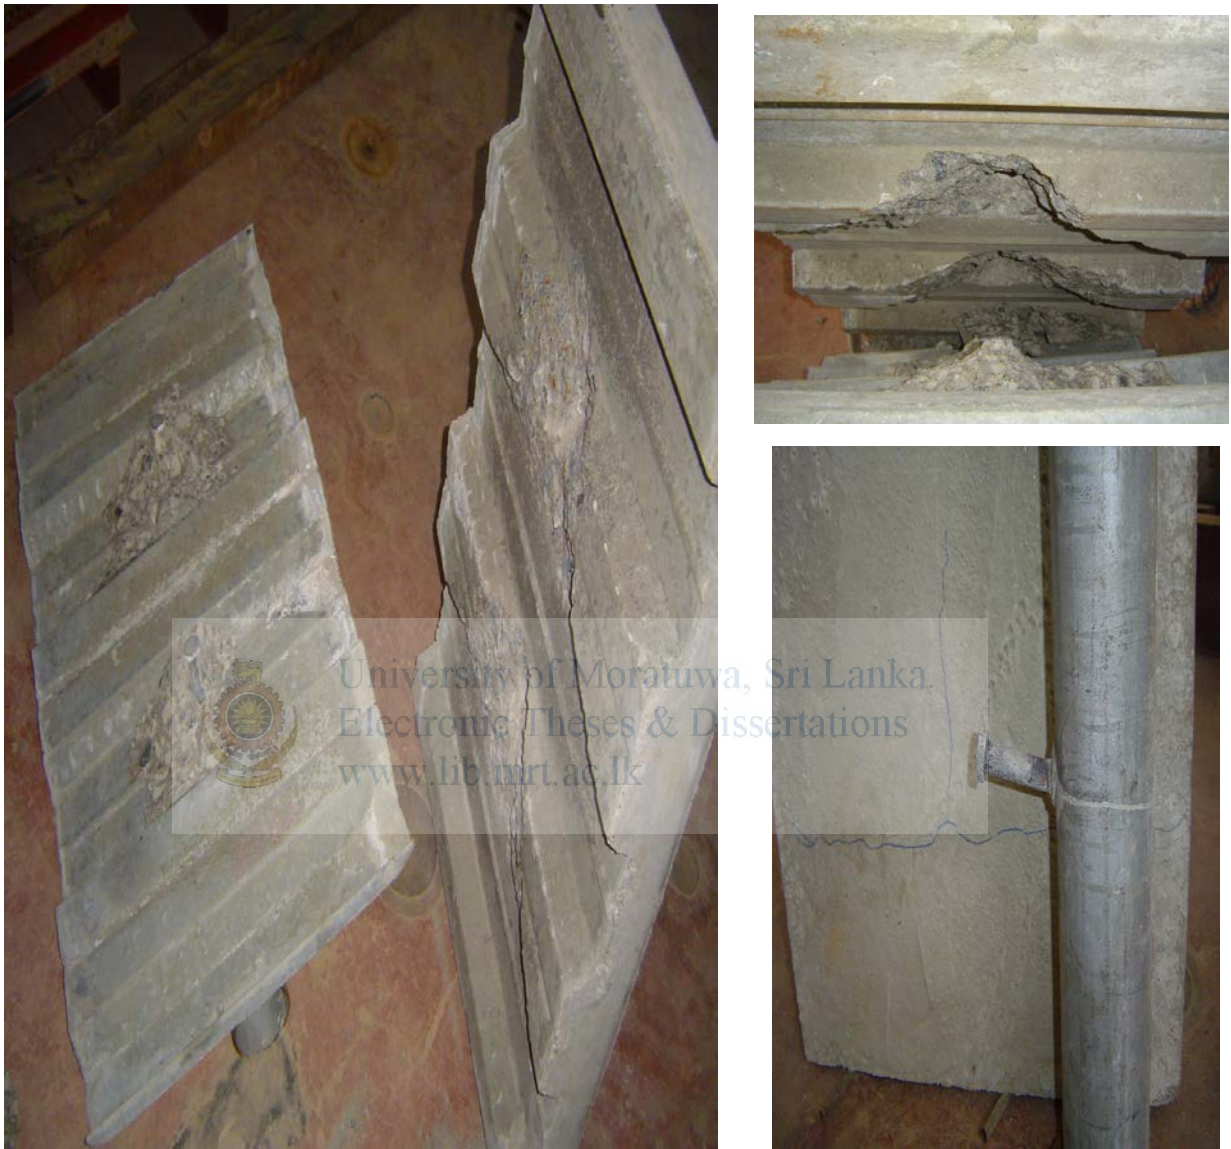
Figure 4.18: Configuration 3 Failure Surface

The shear failure pattern of configuration 3 is shown in Figure 4.17, longitudinal crack, and transverse cracks were propagated on top of the headed shear studs. The failure of the composite slab is mainly due to pulling out of stud it is shown in Figure 4.18 (first crack at nearly 58% of failure load), and it is known as shear cone failure. Wedge cone failures were common, but pyramid cone failures also formed (see Figure 4.10, 4.19).

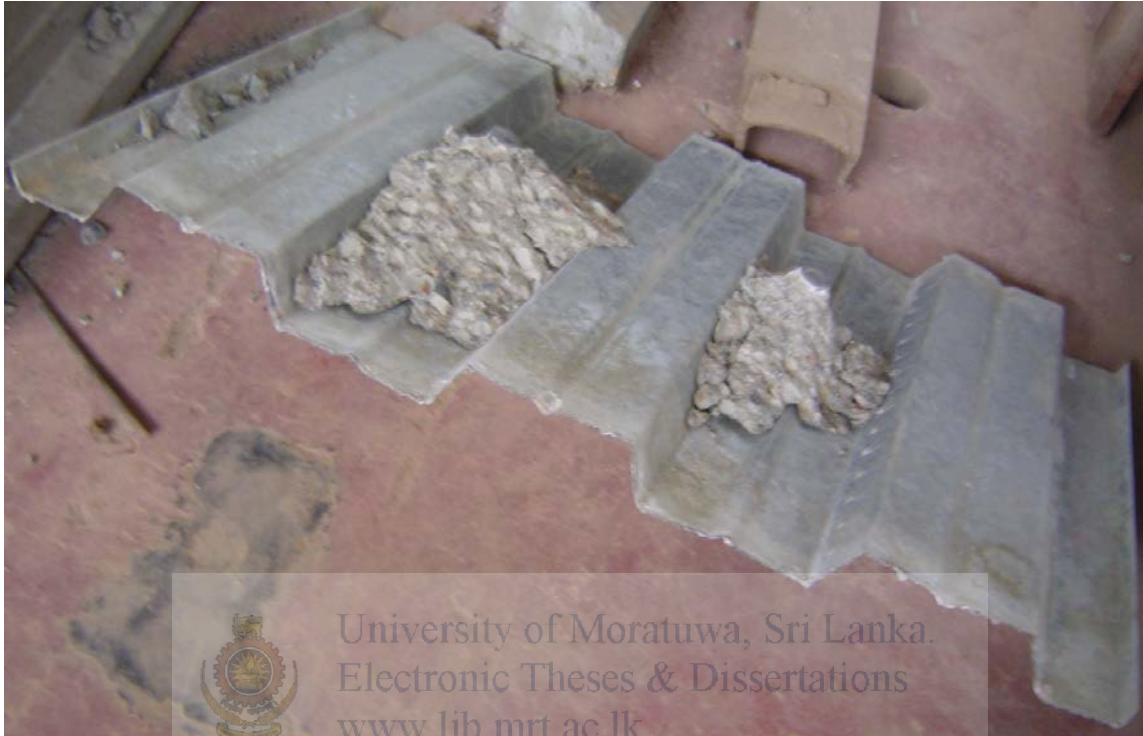
Figure 4.19: Wedge Cone and Pyramid Cone Failure
