## Durability of Cold Formed Steel Structures used in residential and industrial construction

### ABSTRACT

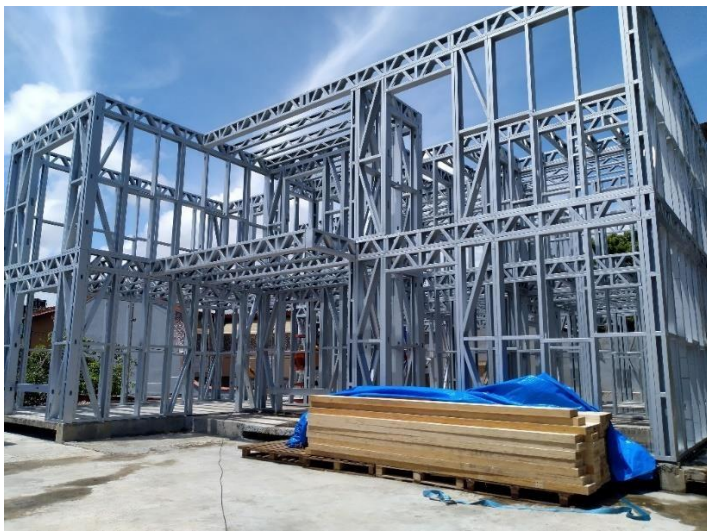
Figure 2: Wall frames in a cold formed steel building

CFS has been used for more than 40 years in roof and temporary construction in Sri Lanka. However, it is relatively new to the construction industry as a structural load bearing element for entire residential construction as shown in Figure 2.

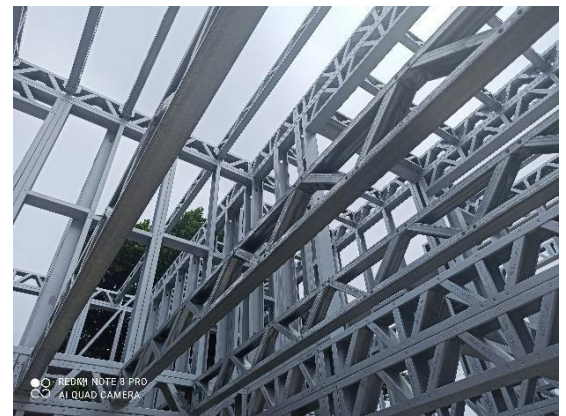
Figure 3: Floor joists in the building

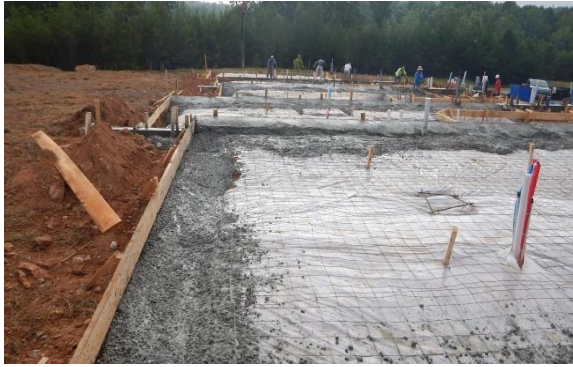
Figure 4: Slab on Grade (Kampert, 2021)

Several methods can be adopted to construct the ground floor. Depending on the bearing capacity of the soil, ground floor can be constructed as a slab on grade as shown in Figure 4 or a suspended concrete slab on pad footing as shown in Figure 5. As it is required to install load bearing steel frames on the slab using anchored connectors, a full concrete slab provides more flexibility to the constructing

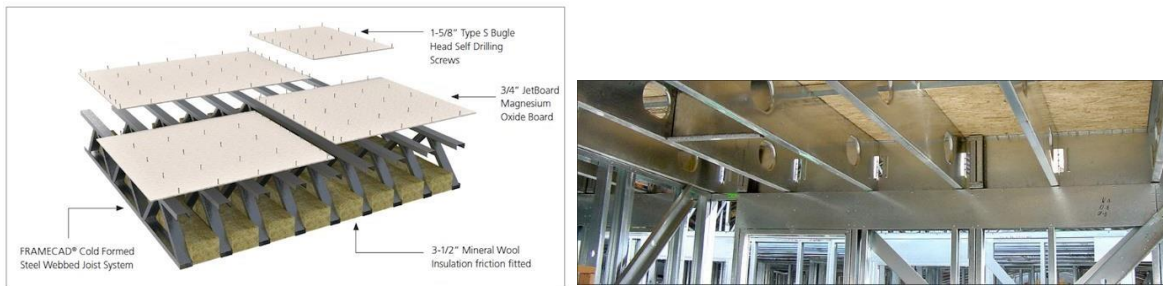
(a) Truss as a joist

(b) C purlin as a joist

Figure 7: Typical Floor in a cold formed steel residential building [Figure 7(a) reproduced from (FRAMECAD, 2022)]

To achieve better insulation and faster construction, similar to timber structures, CFS residential buildings use CFS beams or CFS trusses/joists. Beams or trusses act as a load carrying member and support the timber deck floor as shown in Figure 7. There is an option to have a ceiling underneath the CFS beam or trusses and the insulation is placed between the ceiling and the timber deck. A similar arrangement is used for roof structures and on top of the timber deck, appropriate roofing material.

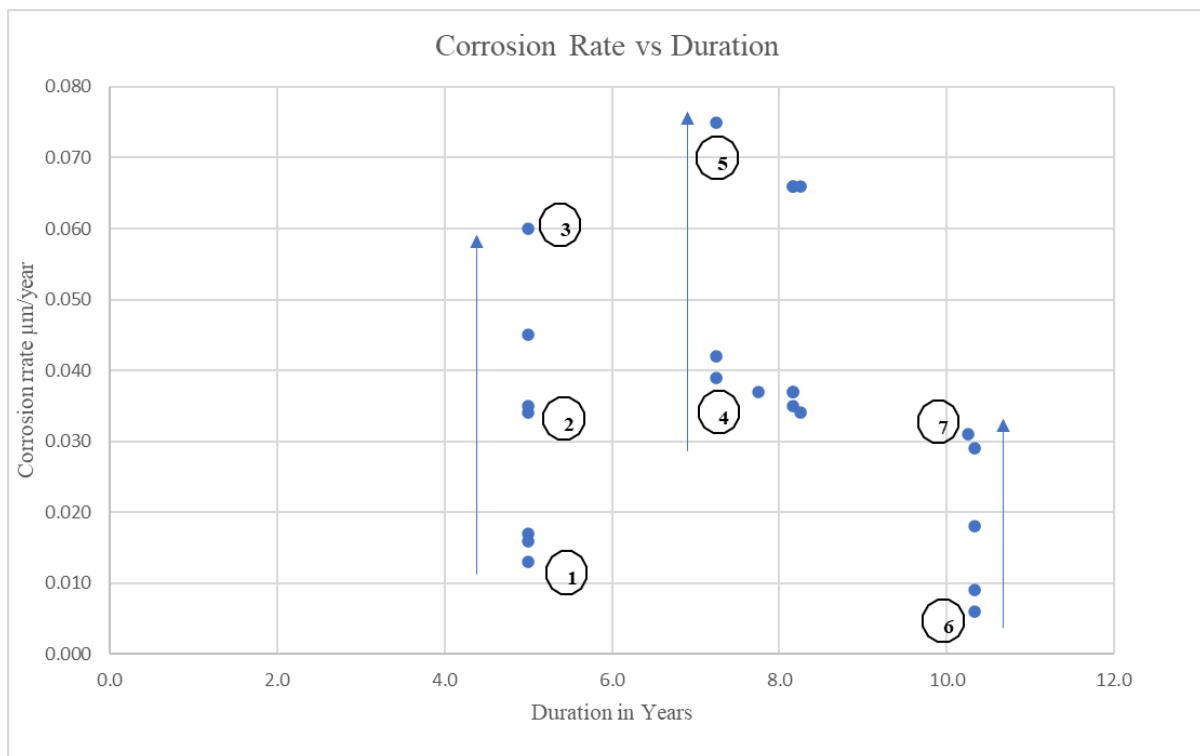
Figure 8: Corrosion rate vs Duration (1- Upper part of a wall, 2- Lower part of a wall, 3 – below ground floor, 4 – Galvanized wall, 5- Galvalume wall, 6 – Upper part of a wall, 7 – below ground floor)

Like walls, attic and loft areas under an enclosed environment, spaces show reduced corrosion rates. However, exposed steel such as CFS below ground floor have seen a significant increase in corrosion rate as shown in Figure 8. A lower rate for upper part of a wall (labelled 1) is noticed while during the same period a 6 times higher rate was observed for exposed steel below ground floor (labelled 3). A similar observation was noticed at different durations as shown in Figure 8.
