Problems and prospects of utilizing canal banks to enhance the built-environment in Colombo

Ranjith Perera

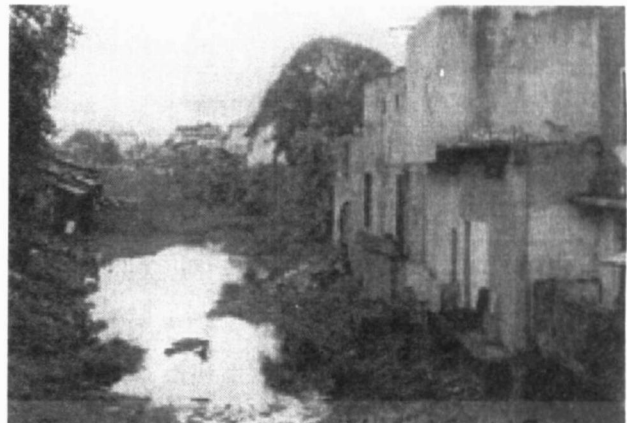
Figure 2: Previous Condition of Canal Banks
(photo credits: Herath, 1996)

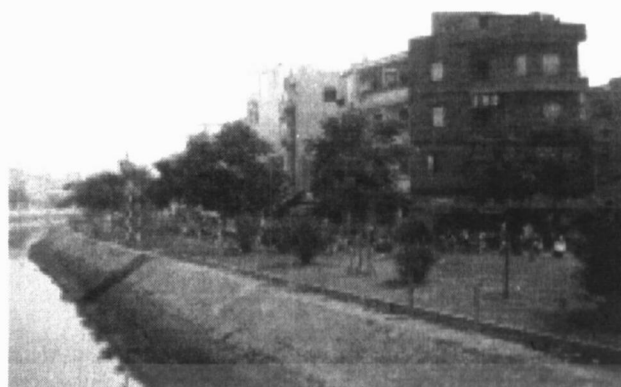
Figure 5: A rehabilitated Canal Bank in Saigon
